CCHS – Envelope Story Board

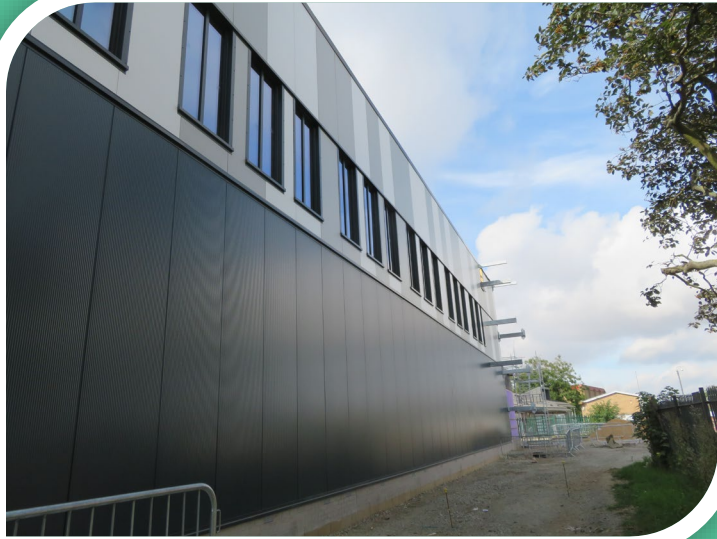
The sports hall is traditionally built. At Clacton the steel frame requires cladding. This cladding is an insulated panel and fixed to the steel frame.

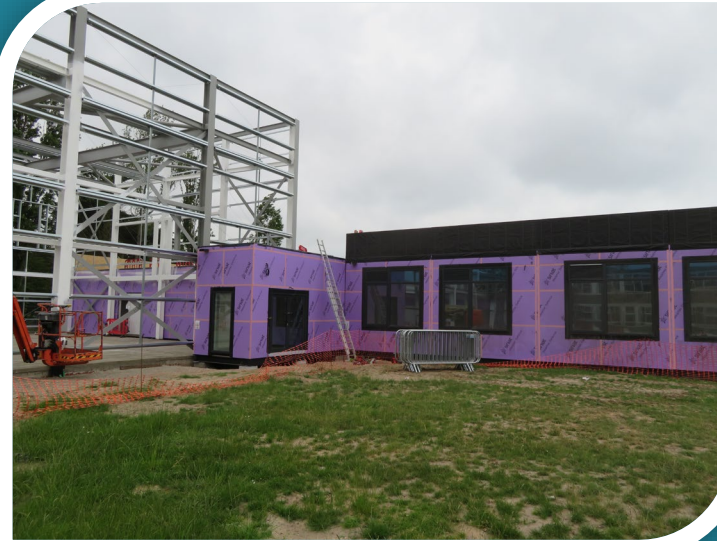
On top of the modules a parapet has been installed to provide a edge protection for operatives that undergo maintenance on the roof. It also acts as a barrier with the services on top of the roof and pedestrians below.

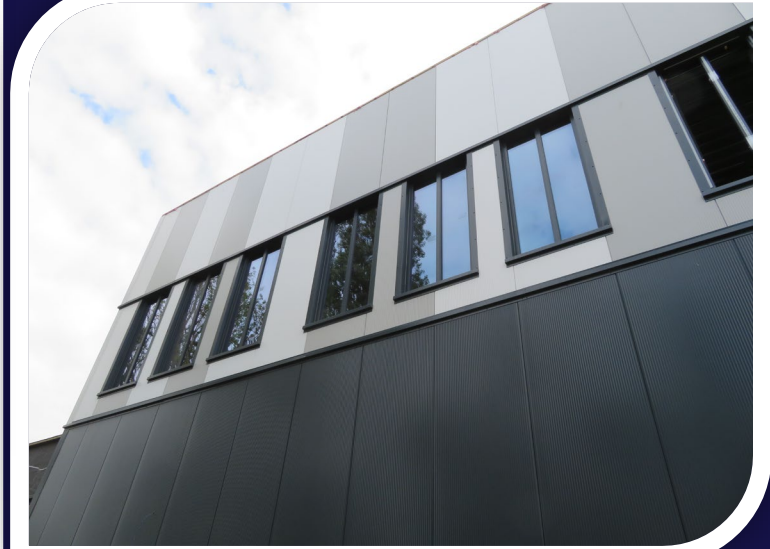
On the north elevation of the sports hall all of the windows have been successfully installed using cherry pickers that work within a exclusion zone to keep everyone safe on site .
